# Manhole Inspection Summary

Manhole # **S27CC\_024MH**

Insp Date: **11/28/07 10:09 AM**

**Location** Address: **1331 ARGYLE AVE**

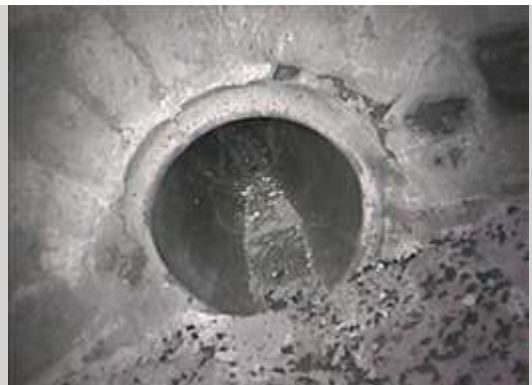
12 O'Clock Outflow

8 in. Circular Gravity Sewer  
Pipe Out @ 12 O'Clock

Deposits: ☐ None ☐ Mud ☐ Sludge ☒ **Debris** ☐ Grease

Silt Depth: **1** (in.) Deposits Extent: **Light**
